PROPERTY INSPECTION REPORT

Inspection Address: 12345 Av. Tomorrow, Laval

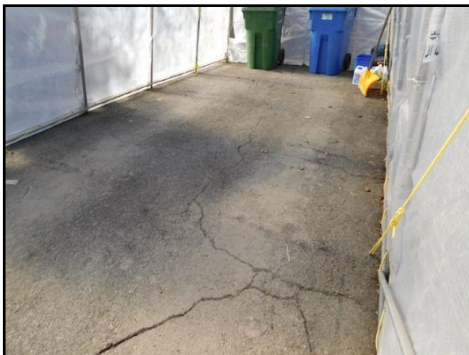
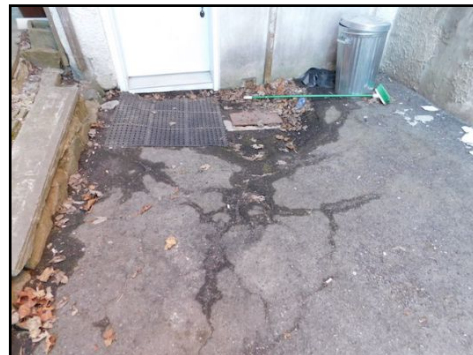
There was some degree of cracking and/or damage present to the driveway asphalt surface. If a concern, have an asphalt paving company or other qualified person to evaluate for repair.

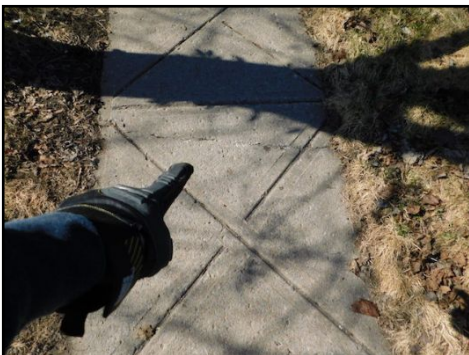
Common cracks and heaved/settled areas observed.

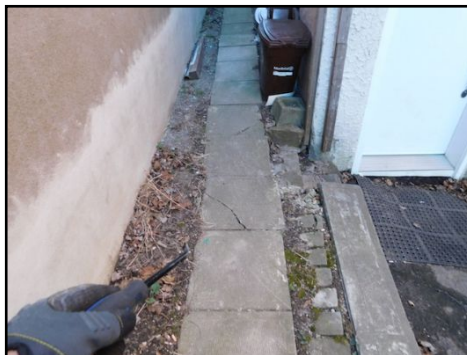
Uneven walkways were observed, this is a trip hazard

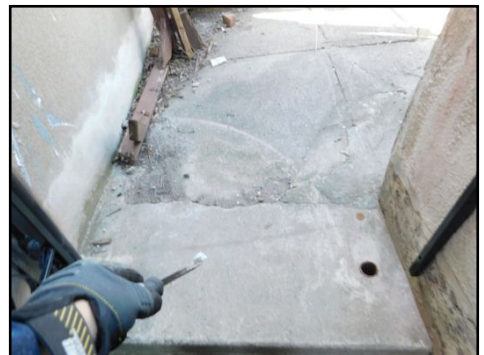
Uneven walkways were observed, this is a trip hazard

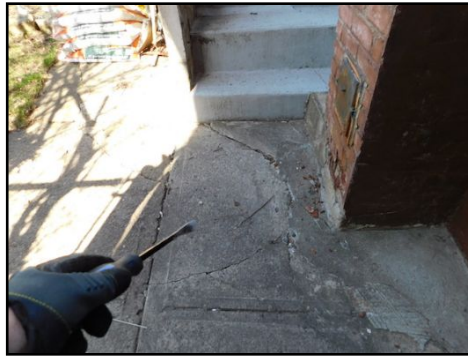
Uneven walkways were observed, this is a trip hazard

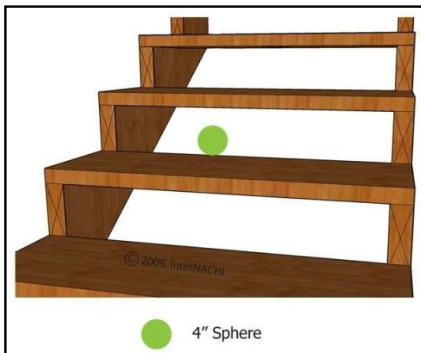
More than 4"spacing is a safety hazard

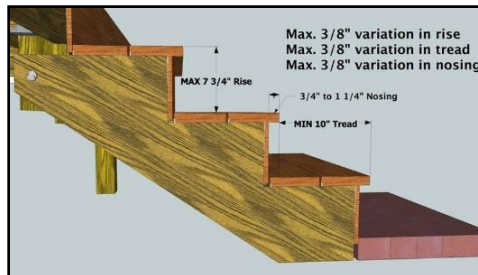
Proper measurements for stairs

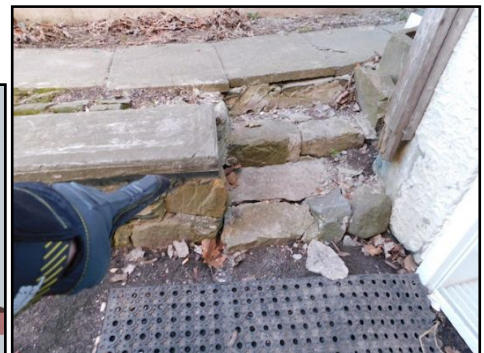
Loose steps/stones observed, by the side walkway. This is a trip/safety hazard. Corrections needed to enhance safety.

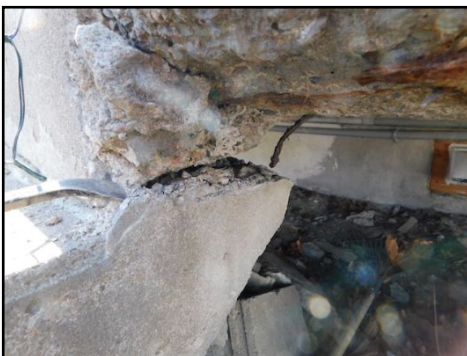
Concrete deterioration and rusted rebar is exposed. Possibility of detaching concrete stairs from the concrete balcony. Further verification is required and repair as needed.

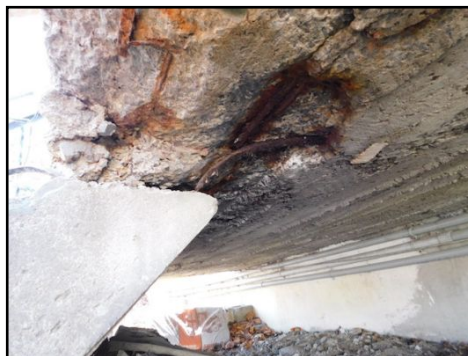
Concrete deterioration and rusted rebar is exposed. Possibility of detaching concrete stairs from the concrete balcony. Further verification is required and repair as needed.

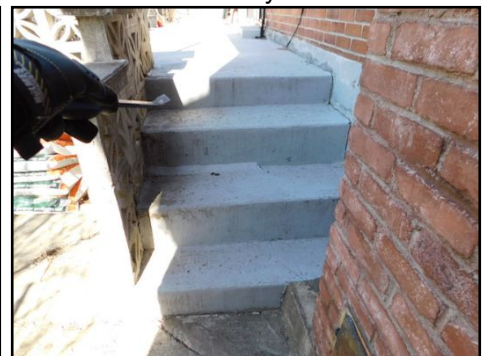
Uneven steps were observed, these are a trip hazard.

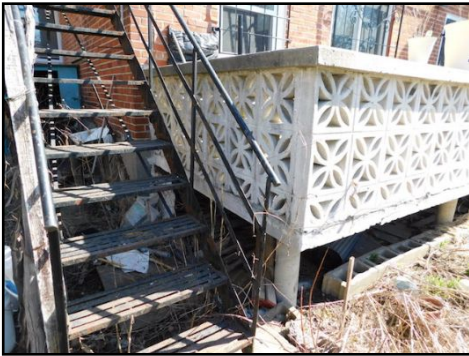
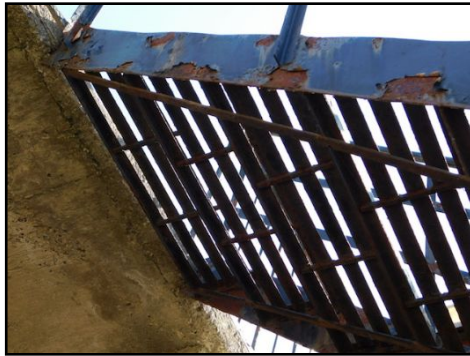
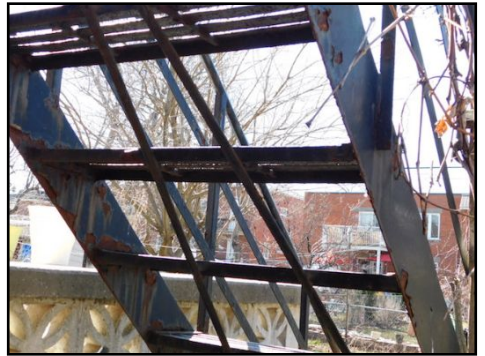
Uneven steps noted. Although this may be typical on older buildings, it is considered a trip hazard. Corrections recommended by a qualified contractor according to the safety standards.

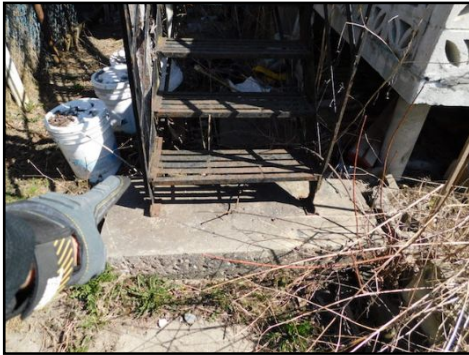
Uneven steps were observed, these are a trip hazard.

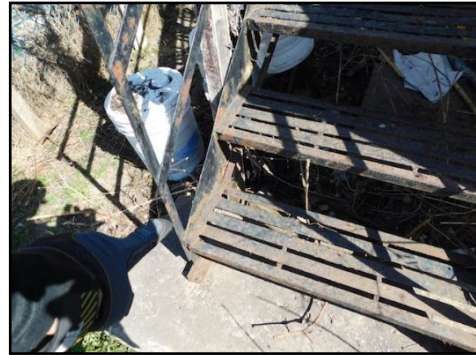
Loose area, safety hazard

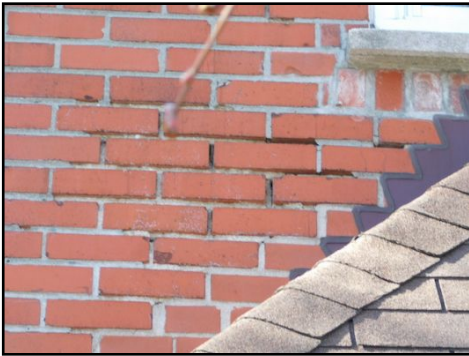
Major repointing needed in multiple areas around the building

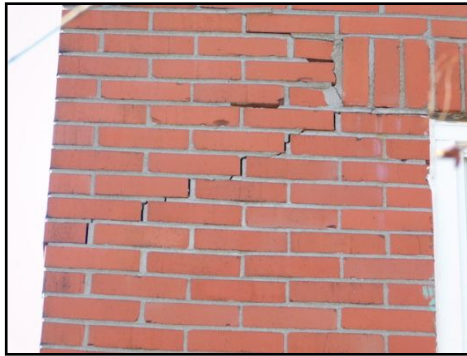
(Step crack active) Cracking visible in brick exterior walls appeared to be consistent caused by differential settling of soil and/or the foundation.

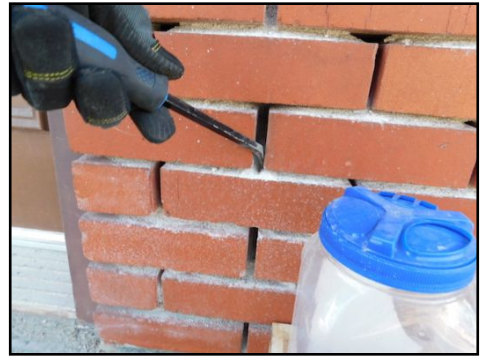
(Soft mortar) Soft and sandy mortar noted on the exterior bricks in various areas around the building. This is often caused due to presence of humidity over time. This condition can absorb more humidity causing further settlement and cracks over time. It is recommended to consult with a qualified masonry for further evaluation and proper corrections along with an accurate estimate of all associated costs before the signing at the notary.

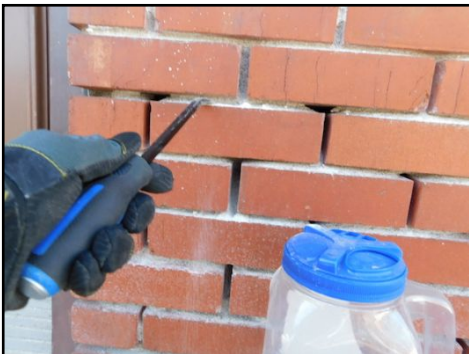
Major repointing needed in multiple areas around the building

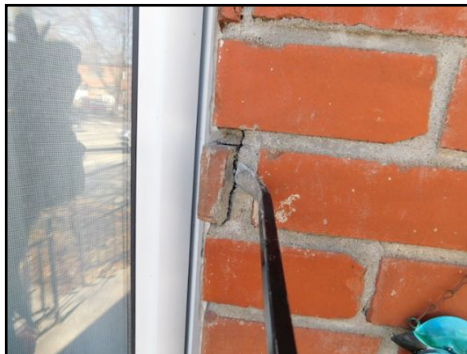
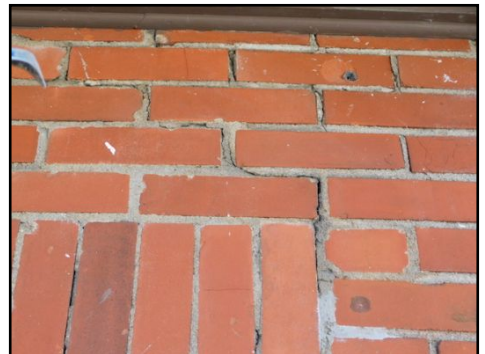
All cracks and openings on exterior coverings should be sealed and repaired to prevent water infiltration and further damages.

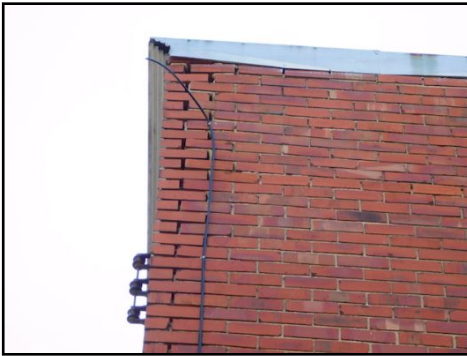
(Brick detachment) Visible brick detachment, and some appear to be bowing outwards was noted on upper portion of the building. This is often associated with water infiltration and freezing and is usually caused by improper flashing of the roof. Repairs and corrections required by a qualified contractor to prevent further damages.

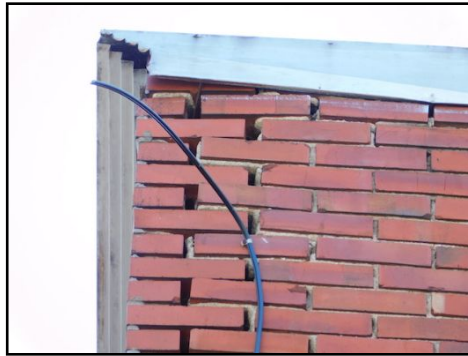
Risk of water entering building/weakened structure/chance of structural movement.

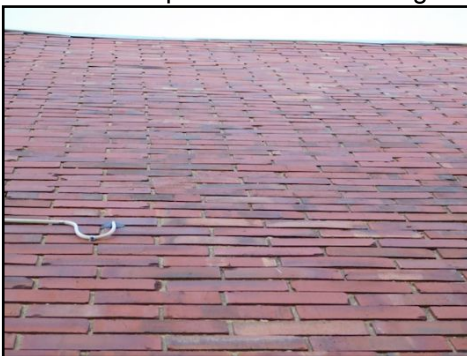
(Brick detachment) Visible brick detachment, and some appear to be bowing outwards was noted on upper portion of the building. This is often associated with water infiltration and freezing and is usually caused by improper flashing of the roof. Repairs and corrections required by a qualified contractor to prevent further damages.

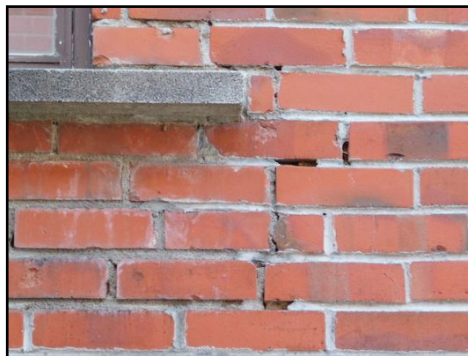
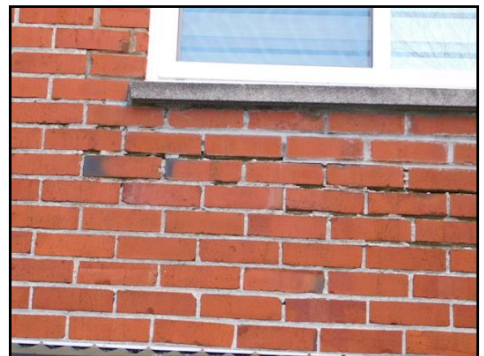
(Soft mortar) Soft and sandy mortar noted on the exterior bricks in various areas around the building. This is often caused due to presence of humidity over time. This condition can absorb more humidity causing further settlement and cracks over time. It is recommended to consult with a qualified masonry for further evaluation and proper corrections along with an accurate estimate of all associated costs before the signing at the notary.

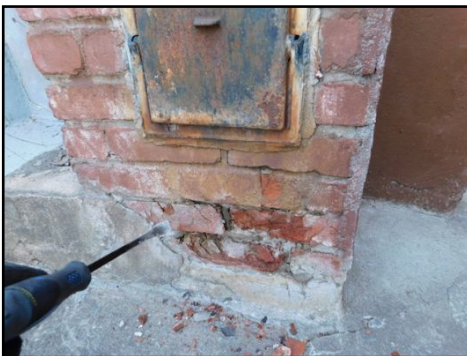
(Brick spalling) Visible brick spalling noted. This is mostly associated with presence of water/moisture behind the bricks. Further investigation and proper corrections is recommended to prevent further damages.

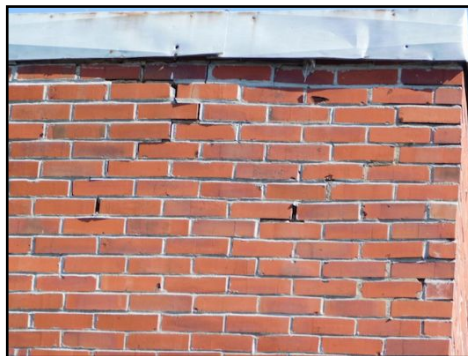
All cracks and openings on exterior coverings should be sealed and repaired to prevent water infiltration and further damages.

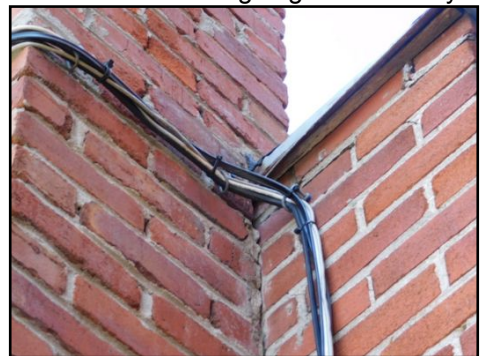
All cracks and openings on exterior coverings should be sealed and repaired to prevent water infiltration and further damages.

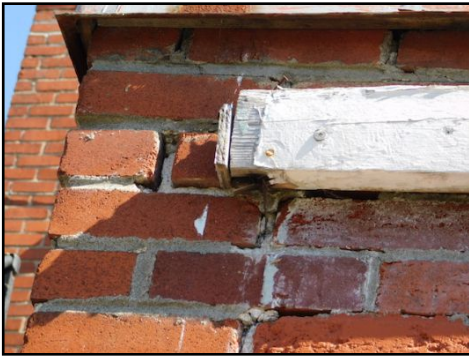
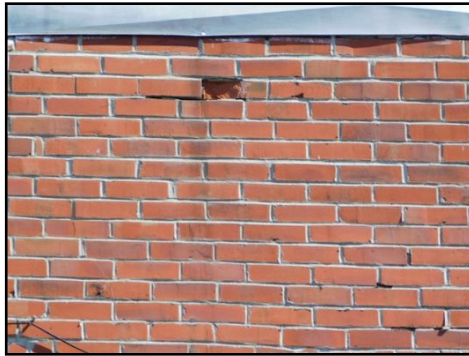
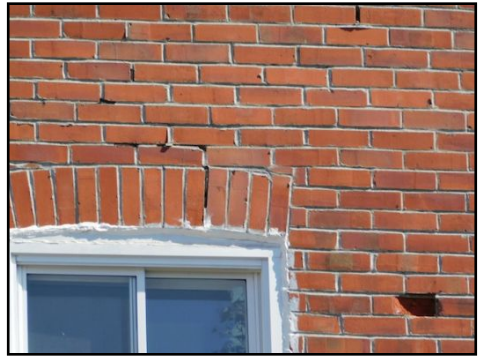
(Brick spalling) Visible brick spalling noted. This is mostly associated with presence of water/moisture behind the bricks. Further investigation and proper corrections is recommended to prevent further damages.

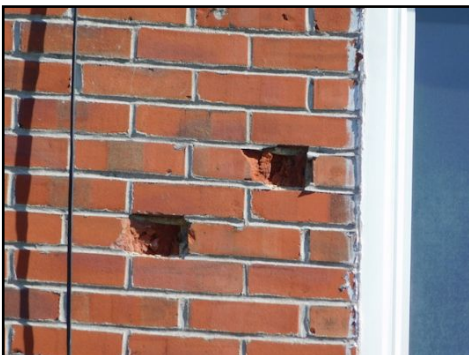
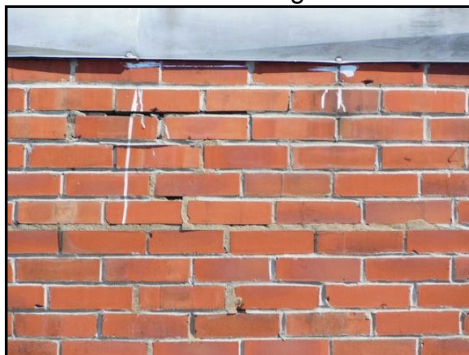
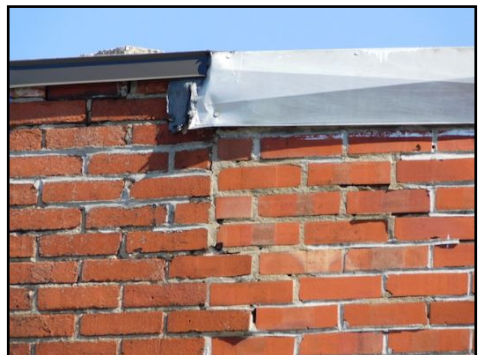
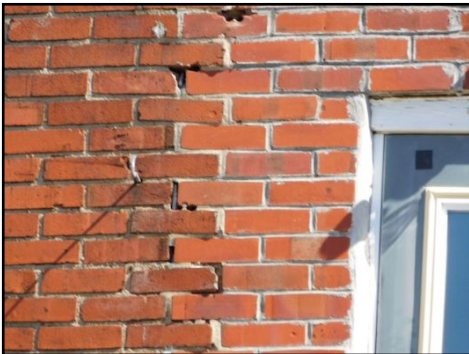
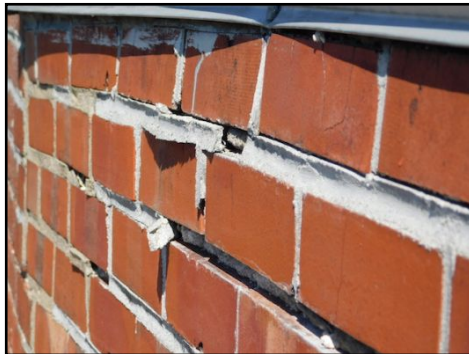
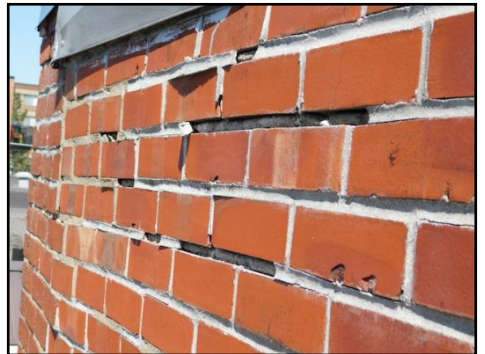
(New mortar over the old one) Overall usable considering the age of the house. However the mortar between the bricks appears to have been re pointed recently, and they have been applied over the original soft and sandy mortar. Although this is often the practical and common way of re pointing, this condition can absorb humidity over time and may lead to detachment and degradation of the new mortar. Close monitoring is required.

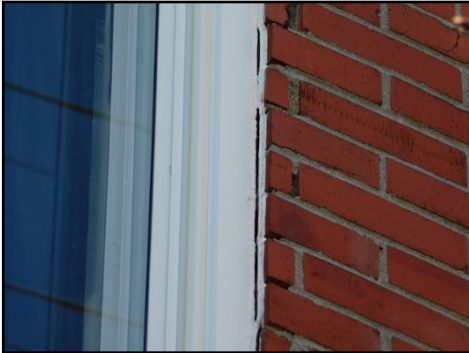
Important caulking needed, there are areas which need immediate repairs to prevent water infiltration, a caulking specialist should be contacted.

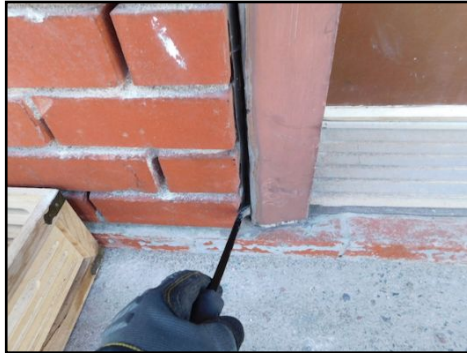
Important caulking needed, there are areas which need immediate repairs to prevent water infiltration, a caulking specialist should be contacted.

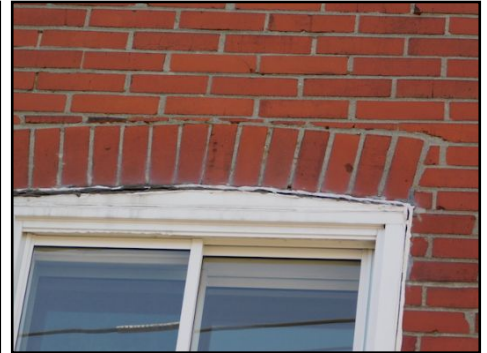
Examples of caulk needed around the house

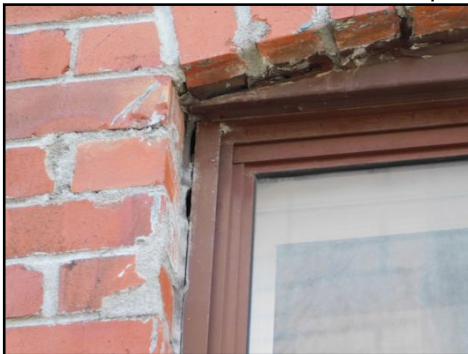
Important caulking needed, there are areas which need immediate repairs to prevent water infiltration, a caulking specialist should be contacted.

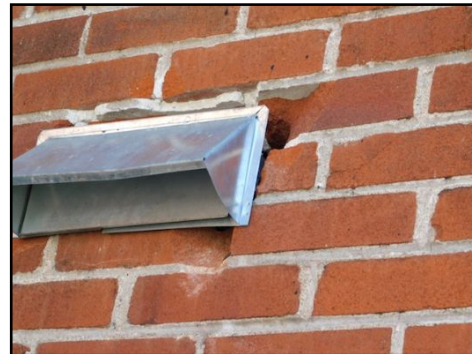
Note: It is recommended to caulk around all fixtures and exterior penetrations. Leaving areas of penetration with missing, improper or defective caulk could result in leakage, rot and/or even the possibility of mould formation. Regular caulk of all potential leakage areas should improve these conditions.

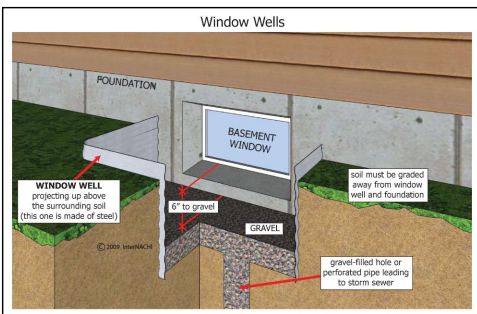
Proper window well installation

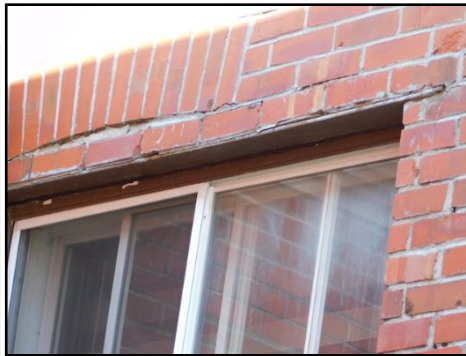
Slight sag observed on the lintel

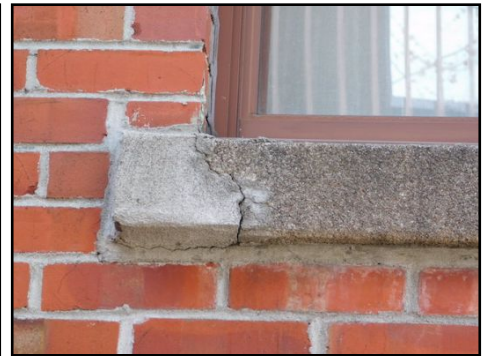
Some sill plates in need of repair/replacement (cracked, damaged/broken off) to prevent water infiltration and further damages.

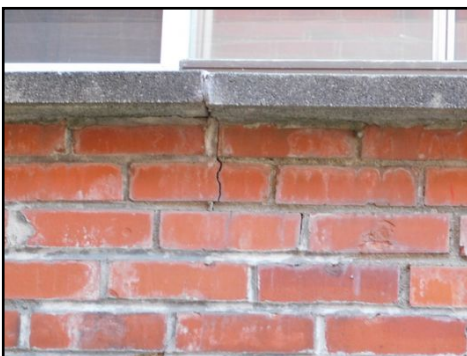
(Openings at the edges of the sill joints) Cracks/openings observed at the edges of the sill joints. This condition can lead to water infiltration and deteriorate the masonry materials below the windows in a faster speed. Repairs and corrections required on a regular basis to prevent degradation and spalling.

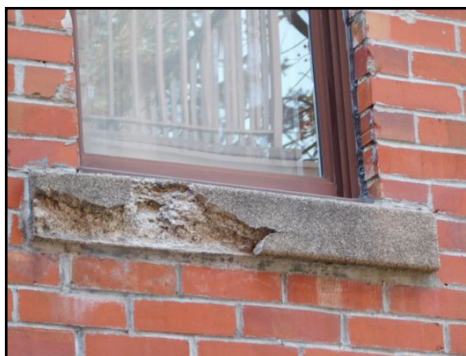
Some sill plates in need of repair/replacement (damaged/broken off) to prevent water infiltration and further damages.

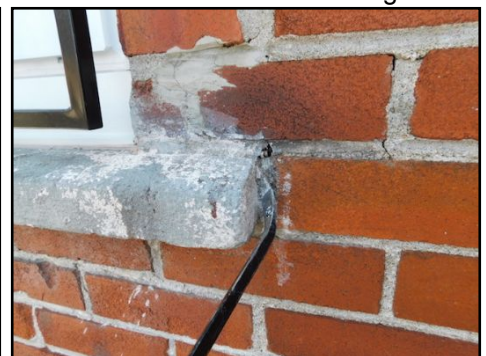
(Openings at the edges of the sill joints) Cracks/openings observed at the edges of the sill joints. This condition can lead to water infiltration and deteriorate the masonry materials below the windows in a faster speed. Repairs and corrections required on a regular basis to prevent degradation and spalling.

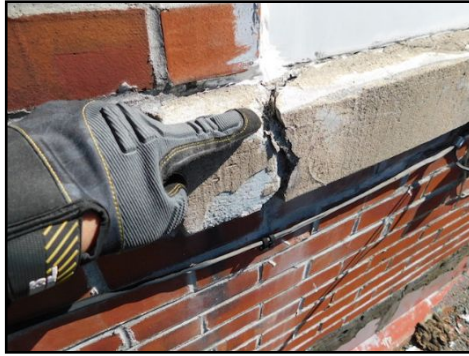
7. Exterior Door Conditions

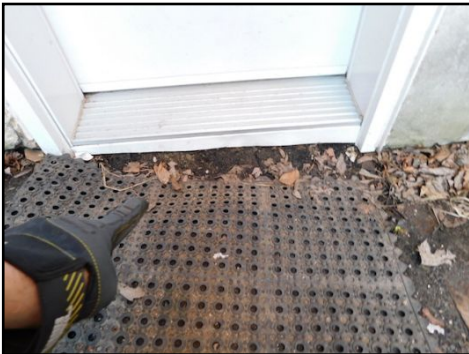
The basement door sill is too close to ground, water could infiltrate, a distance of at least 4 inches from ground is required.

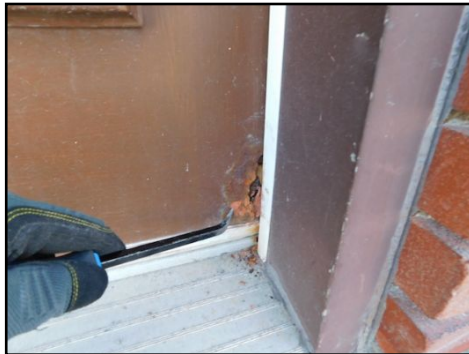
Corrosion, wear and tear observed. Recommend replacing the door (Prevent further rust, perforation and possible water infiltration due to rust)

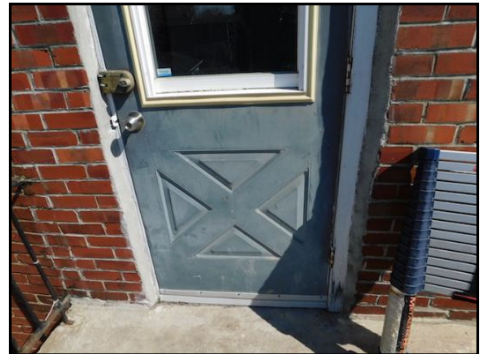
Rear upper balcony door: Opening outward (exterior) with hinges installed on the exterior portion. This condition may be a concern due to the fact that it may be removed. (Security concern)

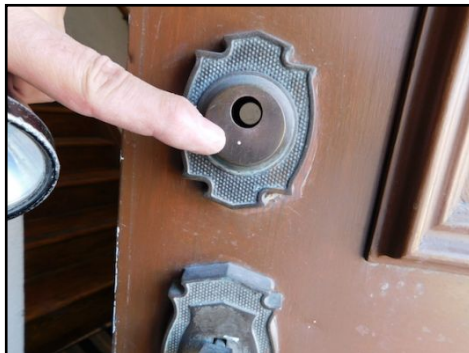
A hole observed in the keyhole area. Repair recommended (#5412)

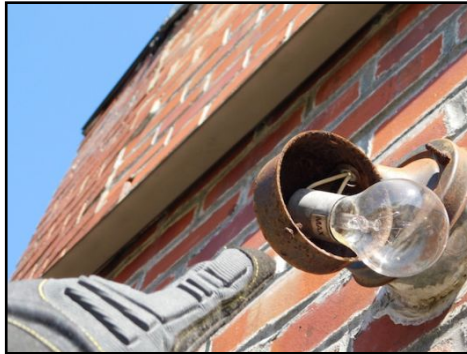
To be repaired, safety hazard

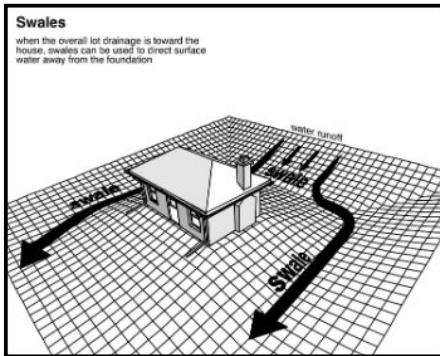
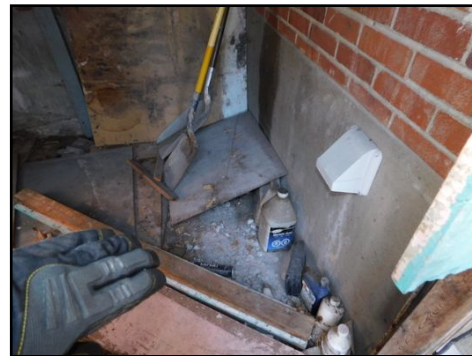
Negative slope in areas

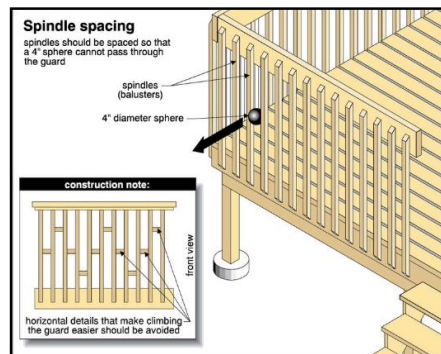
4" maximum space to enhance safety

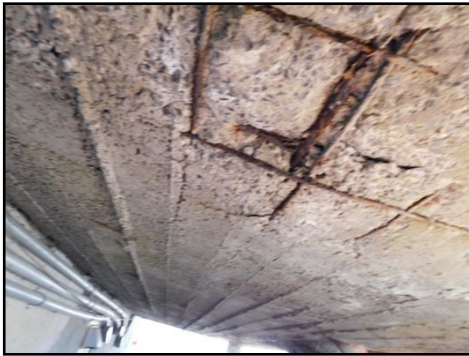
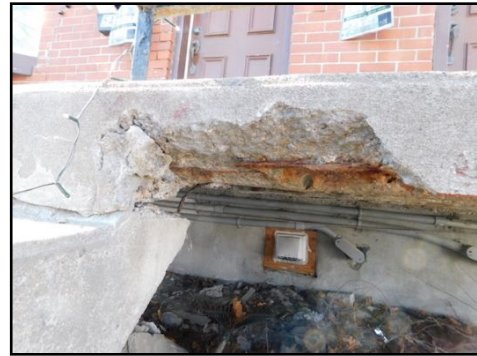
Major crack and surface deterioration observed at the stairs and at front/under the balcony. (Exposed rusted rebar also observed which can weaken the structure)

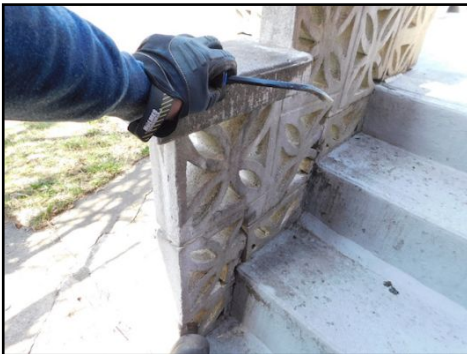
Loose handrail noted with the lower concrete block style handrail. This is a safety hazard. Corrections required to enhance safety.

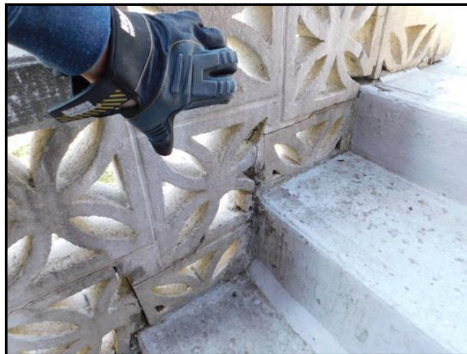
Loose handrail noted with the lower concrete block style handrail. This is a safety hazard. Corrections required to enhance safety.

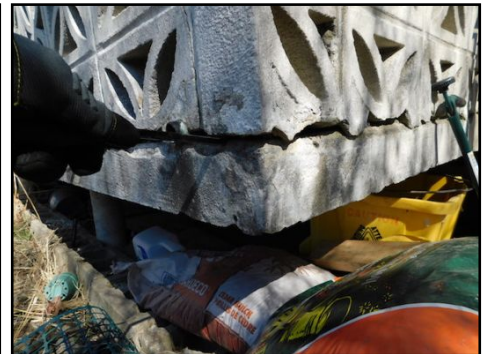
Guardrail is loose/detaching. Important repair needed.

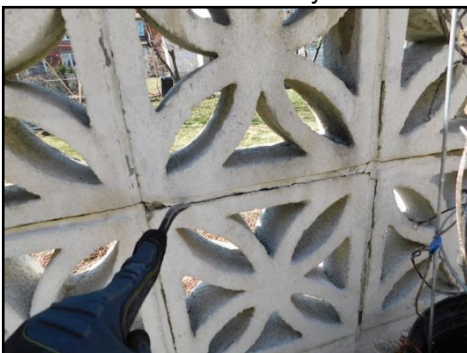
Guardrail is loose/detaching. Important repair needed. (Also a safety hazard)

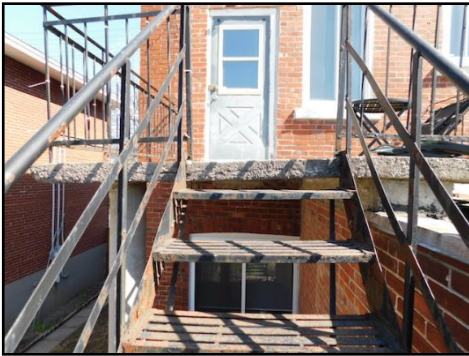
(Concrete) The upper balcony has sloped and cracked due to settlement and or support under an area. Important repairs will be needed.

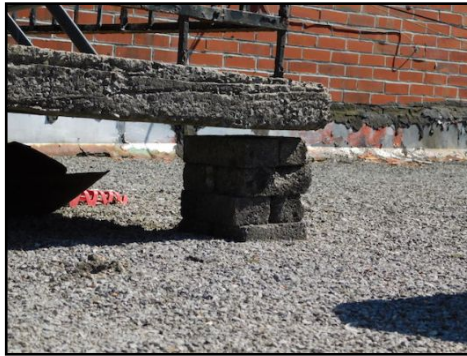
(Concrete) The upper balcony has sloped and cracked due to settlement and or support under an area. Important repairs will be needed.

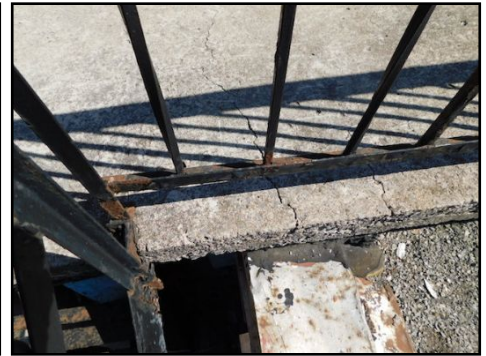
(Concrete) The upper balcony has sloped and cracked due to settlement and or support under an area. Important repairs will be needed.

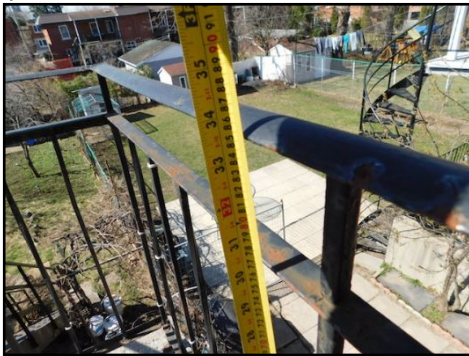
Guard rails height are too low for today's safety standards. Although this is typical based on the age of the construction, it is considered a safety hazard and it should be corrected to enhance safety.

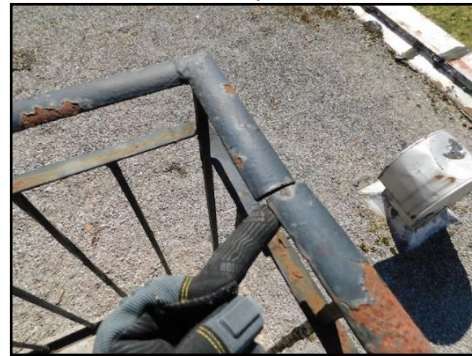
Guard rails cracked open. Replacement needed.

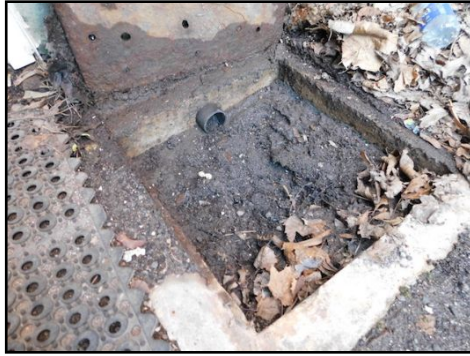
Drain Pit: Overall usable, needs cleaning.

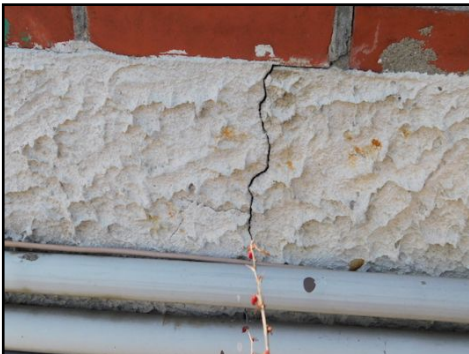
Foundation crack to be verified by foundation specialist and repair as needed

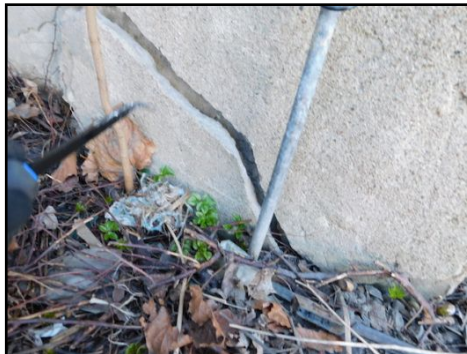
Parge crack, foundation crack was not observed. Limited visibility

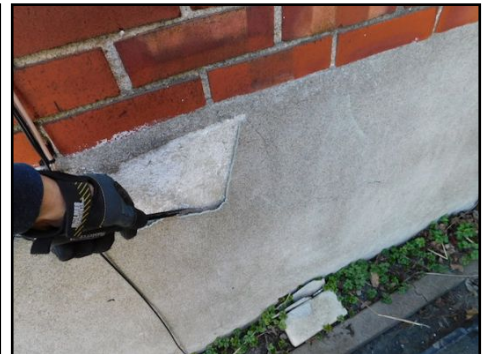
Cement parge coat is flaking/deteriorated in some areas. Recommend review for repair as necessary.

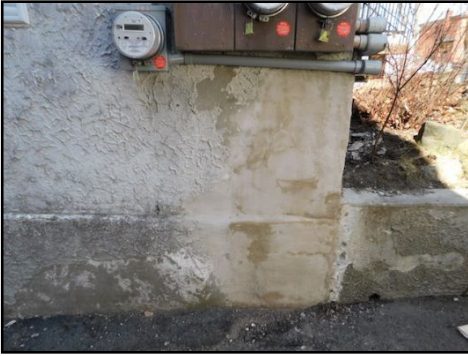
Repaired foundation area. No info provided

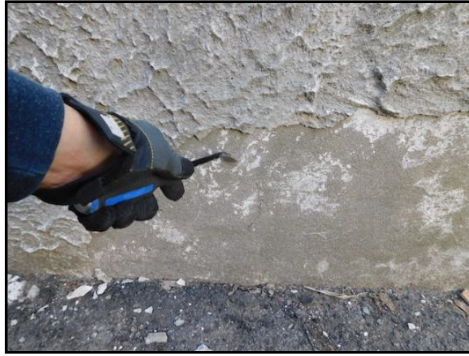
Minor foundation crack

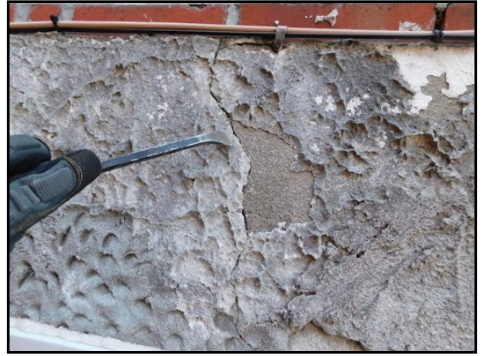
Foundation crack to be verified by foundation specialist and repair as needed

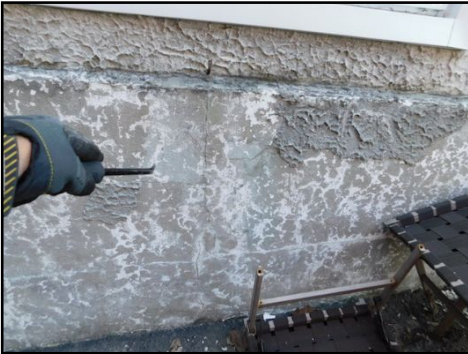
Minor foundation crack observed

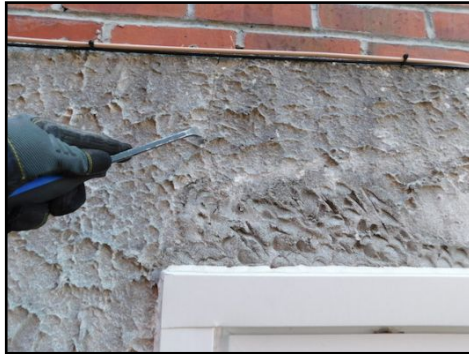
Minor foundation crack observed

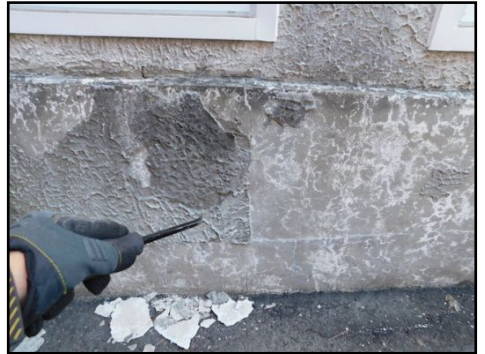
Minor foundation crack observed

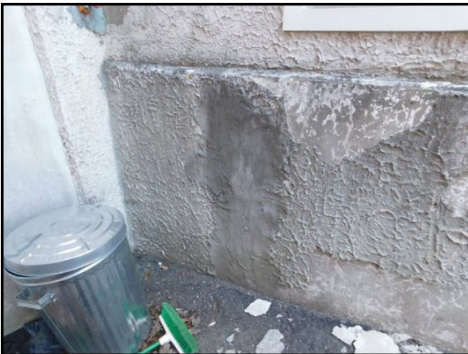
Repaired foundation area. No info provided

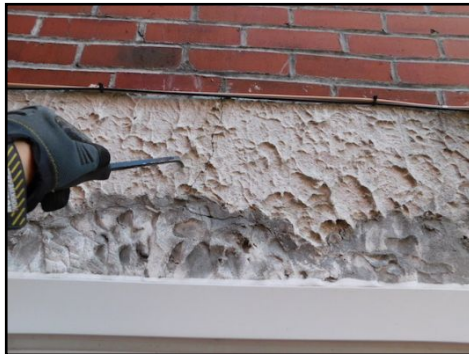
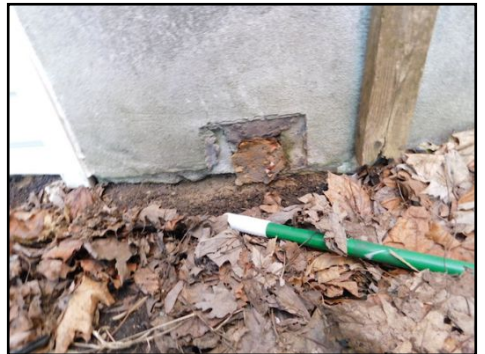
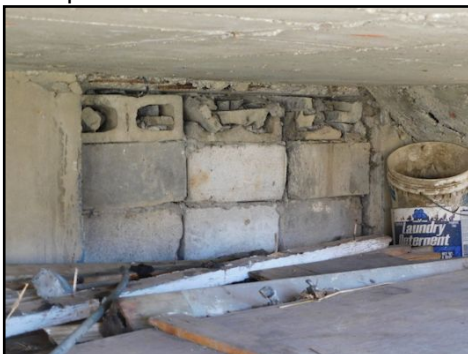
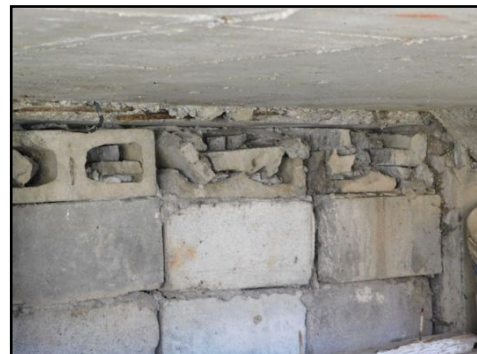
(Concrete block) broken/crumbling cement blocks observed. Immediate further verification is required by a certified foundation specialist and for estimates of repair.

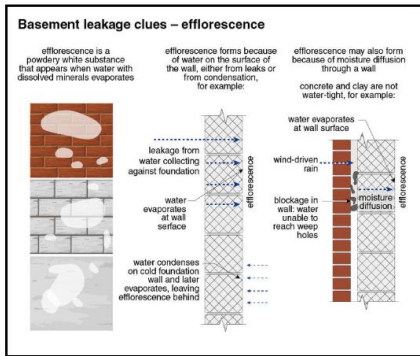
Moisture/efflorescence

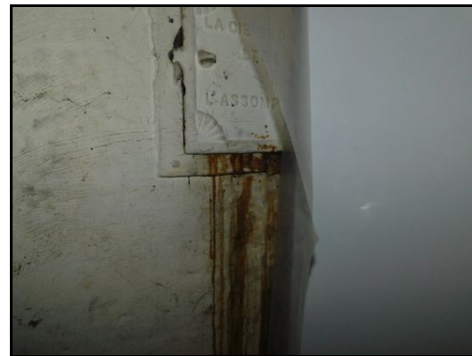
Infiltration from chimney cleanout, Recommend correction in this area

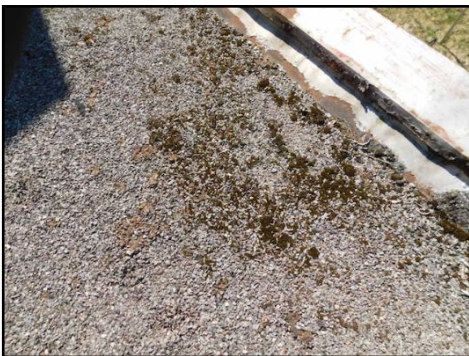
Moss/fungi growth observed. This is often a sign of high level of humidity in the attic area and on the wooden structure, however this was not verifiable due to limited access.

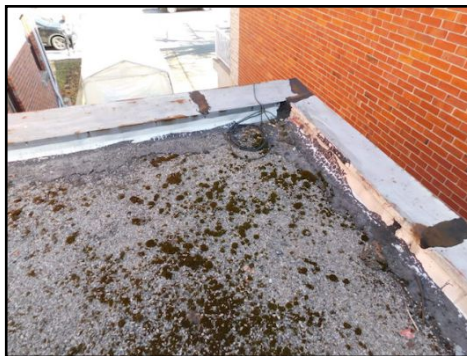
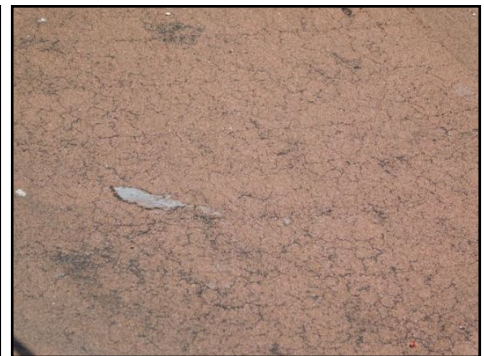
Evidence of patched repairs observed in a few areas (higher rooftop) and appears to be nearing/at the end of its lifecycle due to deterioration and cracks observed.

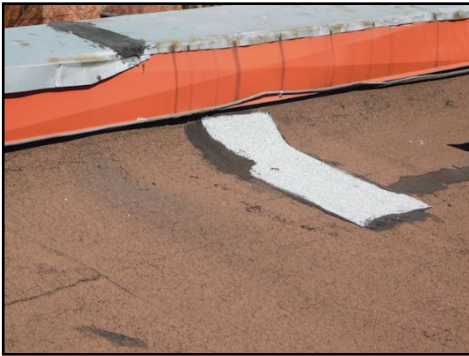
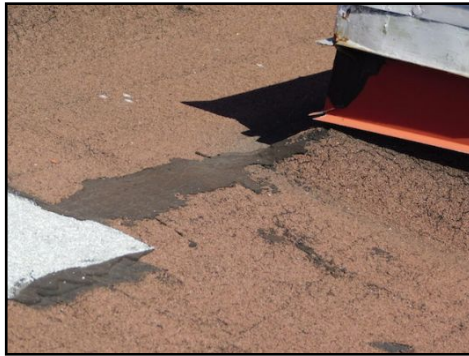
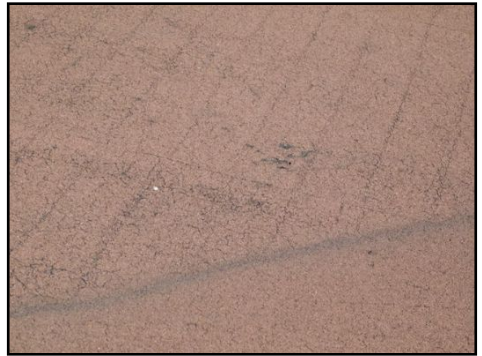
Evidence of patched repairs observed in a few areas (higher rooftop) and appears to be nearing/at the end of its lifecycle due to deterioration and cracks observed.

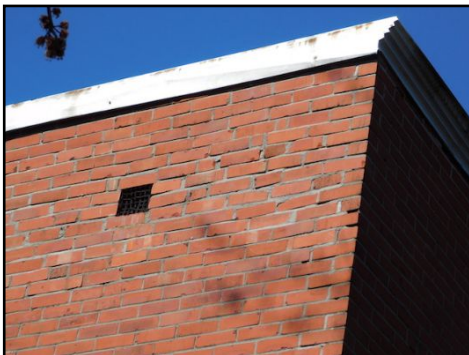
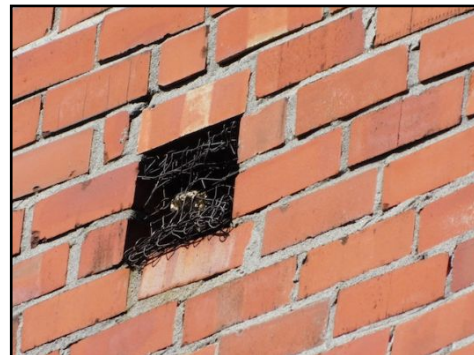
Damaged screen, possibility from animal, and may have entered. Verify and repair screen

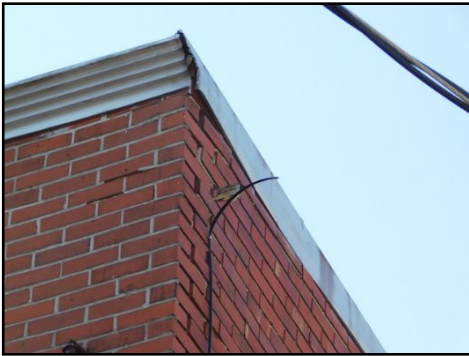
Corrosion, deterioration, openings and poor condition of the caulking was noted on the flashing. This condition can easily lead to water infiltration within the walls. Corrections required by a qualified roofing contractor.

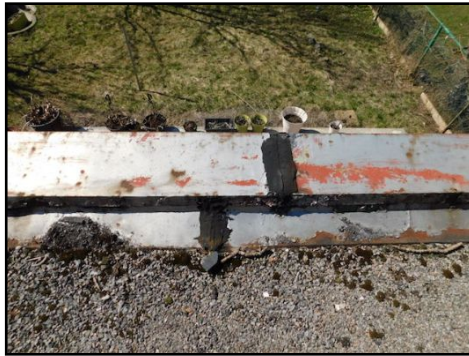
Corrosion, deterioration, openings and poor condition of the caulking was noted on the flashing. This condition can easily lead to water infiltration within the walls. Corrections required by a qualified roofing contractor.

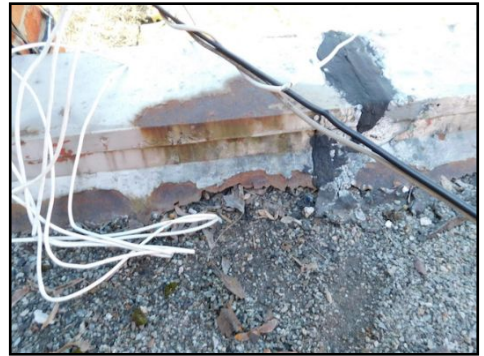
Corrosion, deterioration, openings and poor condition of the caulking was noted on the flashing. This condition can easily lead to water infiltration within the walls. Corrections required by a qualified roofing contractor.

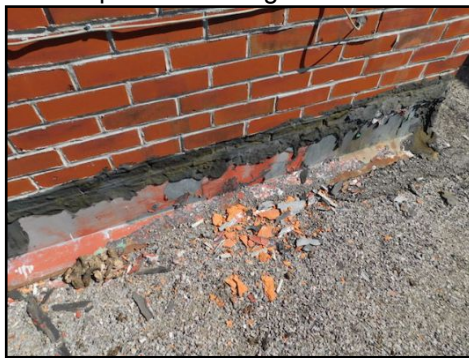
7. Skylight Condition

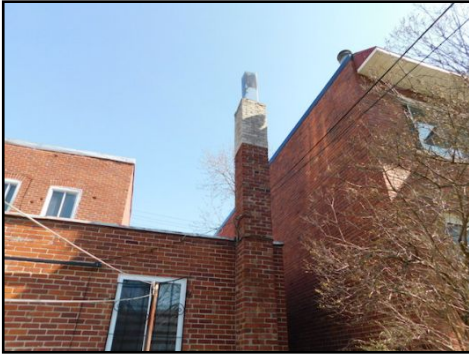
It is recommended to completely remove the abandoned masonry chimney with proper capping to prevent water infiltration.

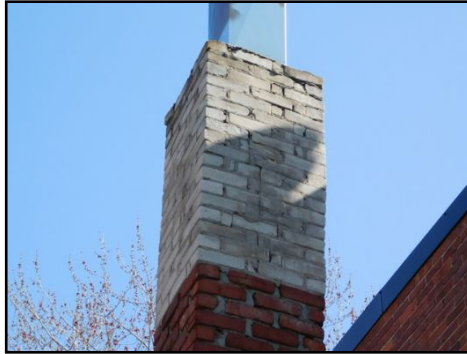
Brick damaging, spalling and mortar deterioration observed. This condition will only get worst if not repaired immediately due to water infiltration. Further investigation is required by a qualified contractor for proper repairs and corrections.

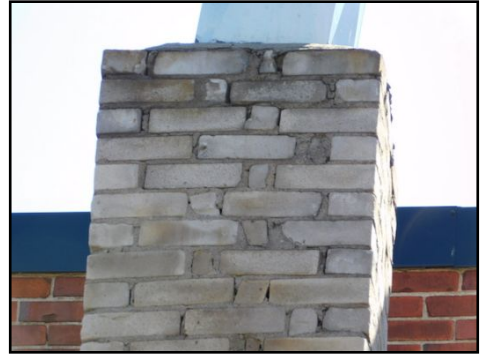
Brick damaging, spalling and mortar deterioration observed. This condition will only get worst if not repaired immediately due to water infiltration. Further investigation is required by a qualified contractor for proper repairs and corrections.

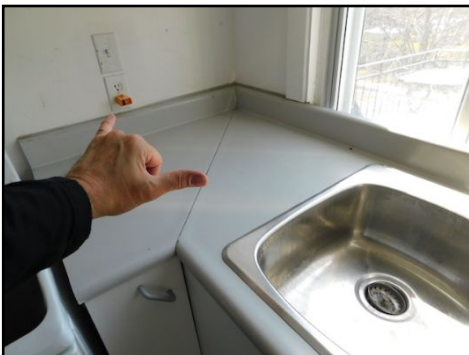
Electrical: - Outlet next to the sink not protected with GFCI. This is a safety hazard and it should be corrected to enhance safety.

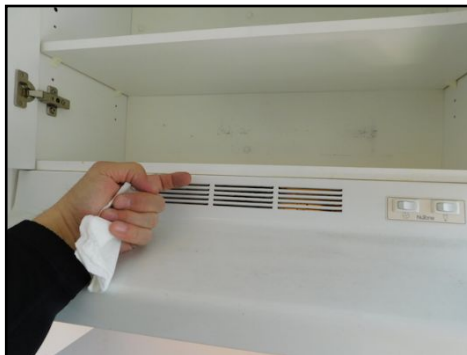
Hood Fan does not vent to the exterior. Recommend having it vent to the exterior.

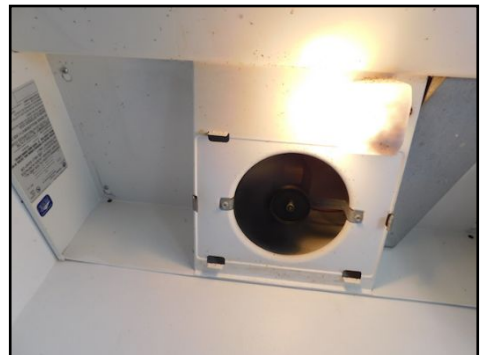
Hood fan: Missing screen, installing one is recommended to enhance safety.

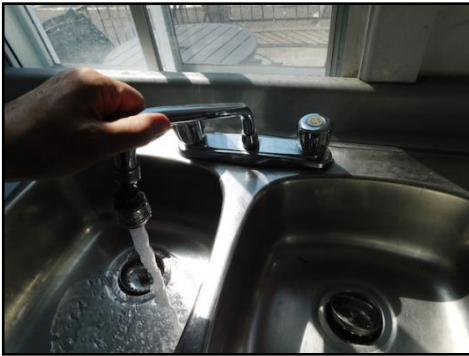
Faucets: - Usable. (No leaks at the time of the inspection)

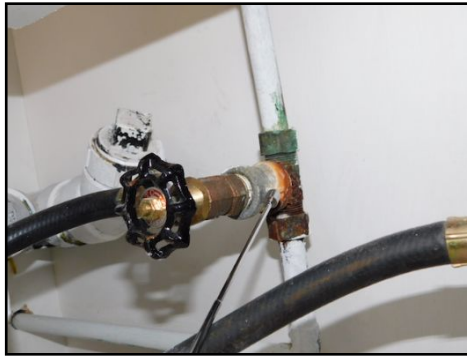
Traps/Drain/Supply: connection observed containing galvanized steel and corrosion observed on it. This may not be accepted by the insurance. Replacement required prevent water leaks.

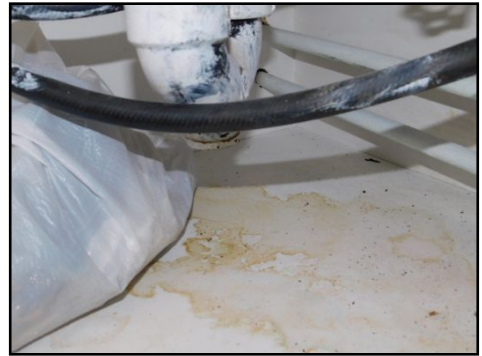
Previous water stains under the sink area

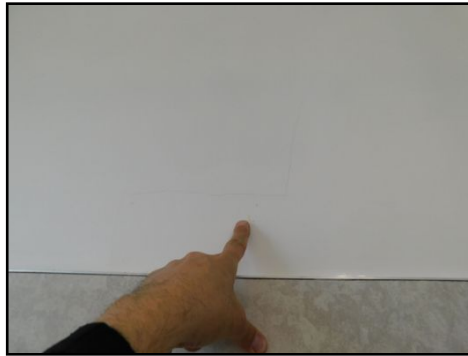
Toilet: Usable, with proper flushing.

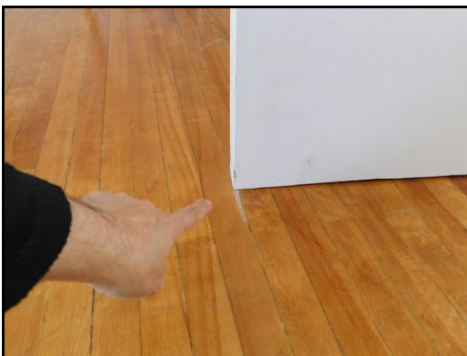
Door rubs on the floor, adjustment needed

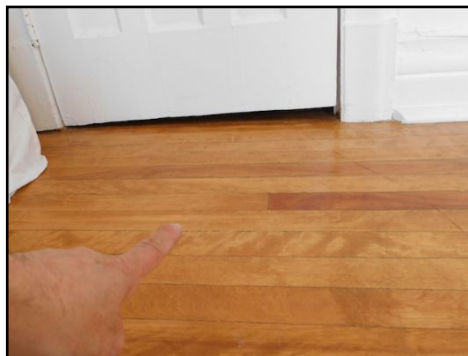
Floors: Sloping/central compression observed. See structure section for more info.

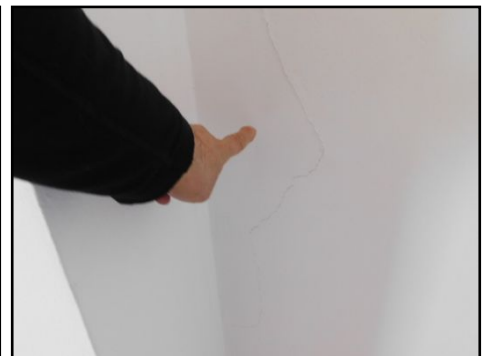
Walls and ceilings: Drywall/plaster, evidence of minor stress cracks.

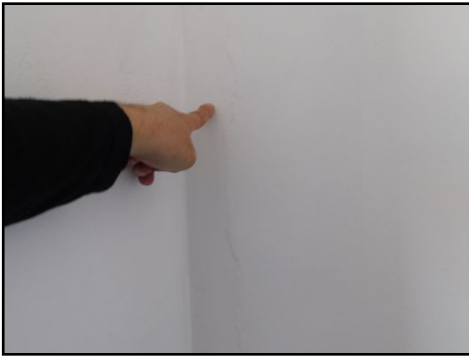
Walls and ceilings: Drywall/plaster, evidence of minor stress cracks.

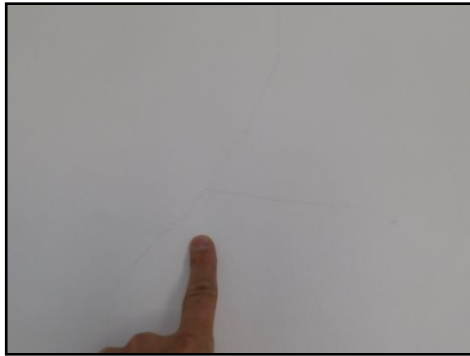
Walls and ceilings: Drywall/plaster, evidence of minor stress cracks.

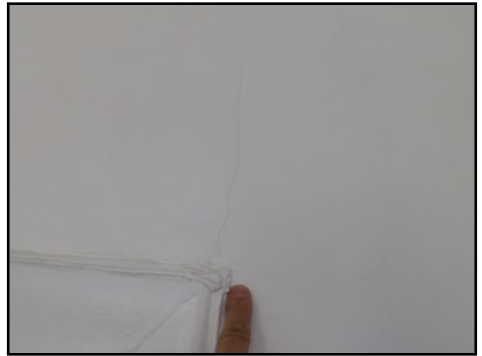
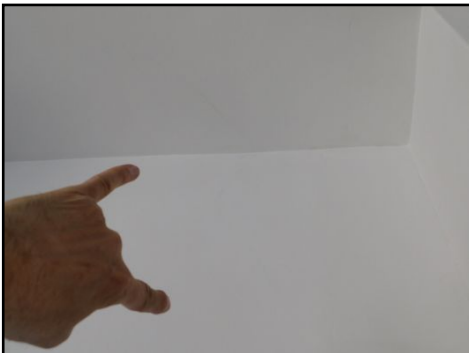
Walls and ceilings: Drywall/plaster, evidence of minor stress cracks.

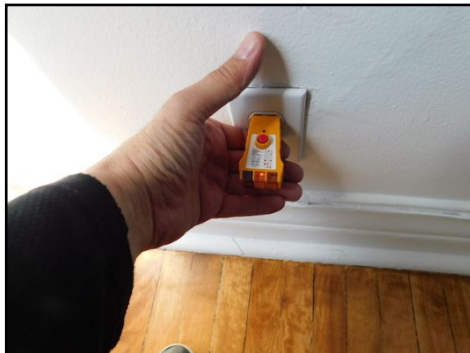
Electrical: Outlets are NOT grounded (Also see main electricity).
