PROPERTY INSPECTION REPORT

Inspection Address: 12345 Av. Tomorrow, Laval

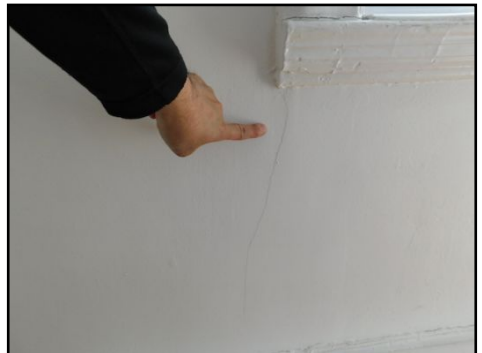
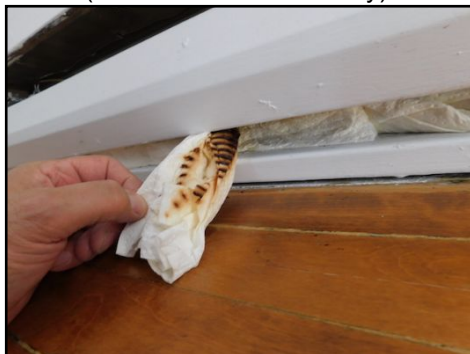
Electrical: One of the bedroom heaters had paper towels placed in the opening. Part of the paper towels were burnt. Serious fire hazard. This should be removed immediately.

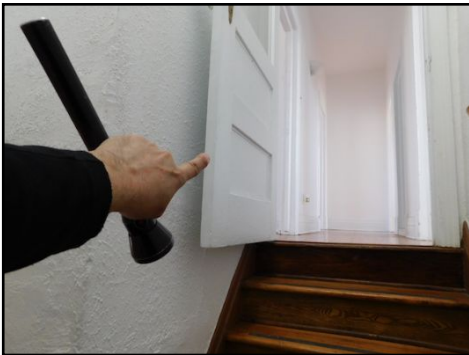
The door opens outward (over the stairs). This is considered a trip hazard and it should be corrected to be opened outward. Corrections recommended to enhance safety.

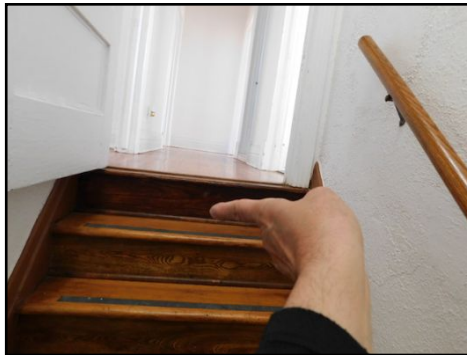
Floor levelling: Sloping/central compression observed.

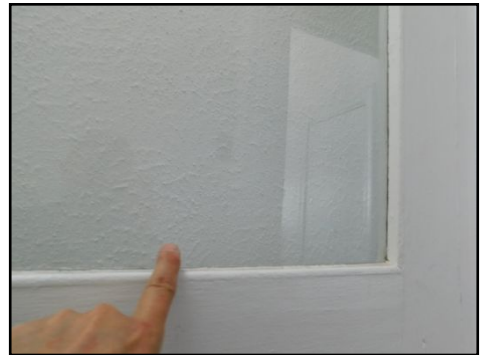
Door over stairs does not have tempered safety glass, this is a safety hazard.

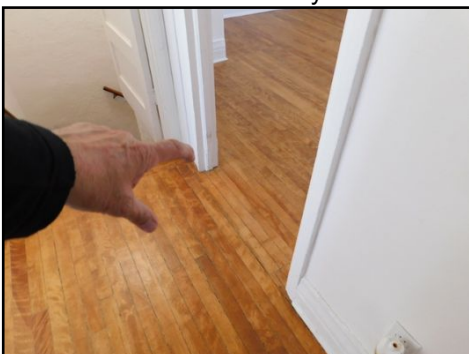
Floor levelling: Sloping/central compression observed.

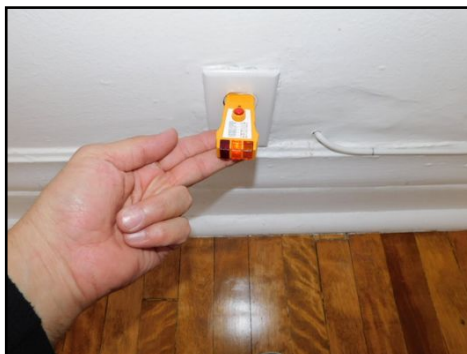
Electrical: - Outlets are not grounded (Also see main electrical).

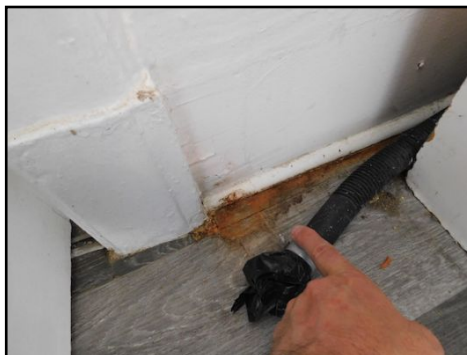
Washer hook ups: They appear to be connected under the sink area. Previous moisture stains observed on the drain pipe which is lying on the floor. Also, no drain for the drain pipe observed. One may need to be installed.

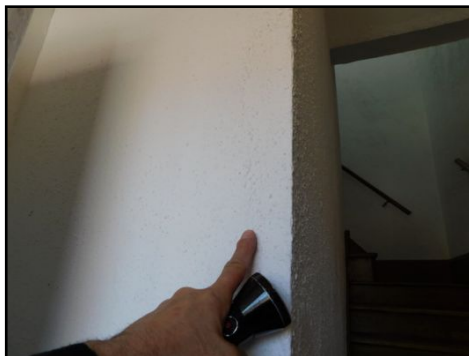
(Plaster/asbestos) General note on houses built up to 1989: Older buildings with plaster walls, drywall, joint compound, stucco, vinyl adhesive, and other building materials may contain asbestos. Please note that sampling and laboratory analysis are beyond the scope of this inspection. If the client wished further detailed information, a certified laboratory should be consulted.

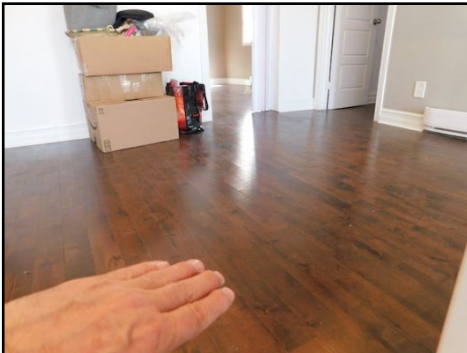
Floor: Hardwood. Overall usable with minor wear and tear. Minor sloping/compression observed

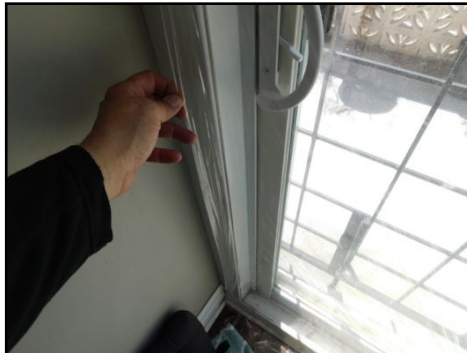
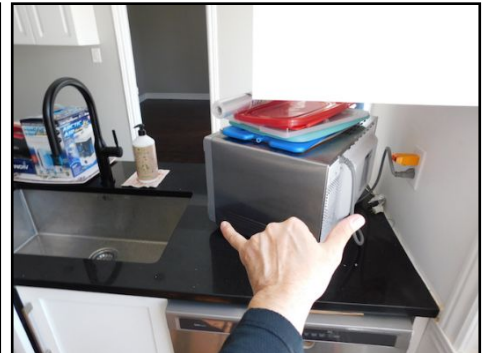
Electrical: - Outlet next to the sink not protected with GFCI. This is a safety hazard and it should be corrected to enhance safety.

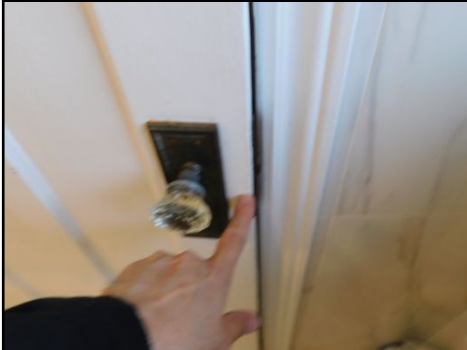
Bathroom door does not latch, adjustment needed

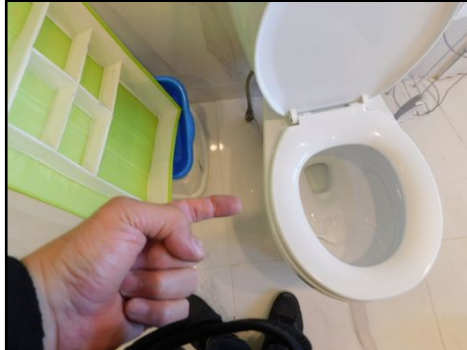
Toilet: Loose toilet was observed. This condition could result leakage and damages to the subfloor and other components. Corrections are required.

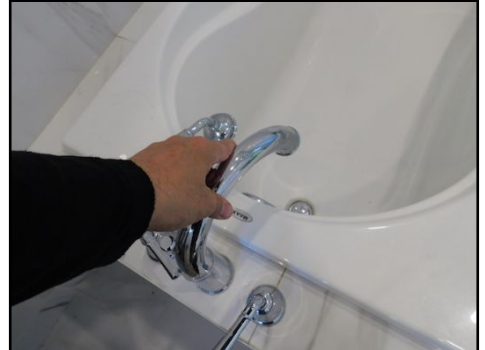
Plumbing fixture: - Loose bathtub faucet (No leaks noted). - Adjustment and application of silicone required to prevent water infiltration.

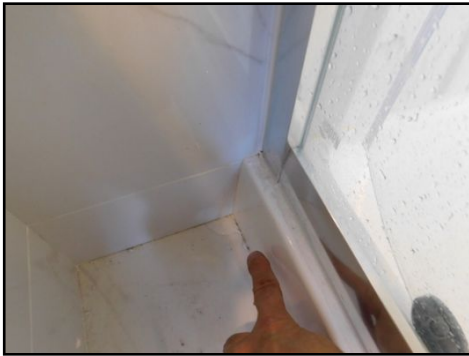
Standing shower and surrounding: Prefabricated fiberglass. Leaks noted (on both edges of the shower surrounding) at the time of the inspection. Repair required to prevent water damage.

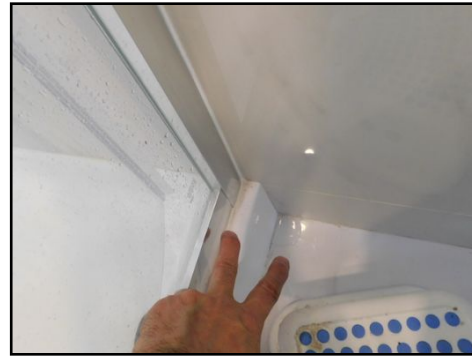
Standing shower and surrounding: Prefabricated fiberglass. Leaks noted (on both edges of the shower surrounding) at the time of the inspection. Repair required to prevent water damage.

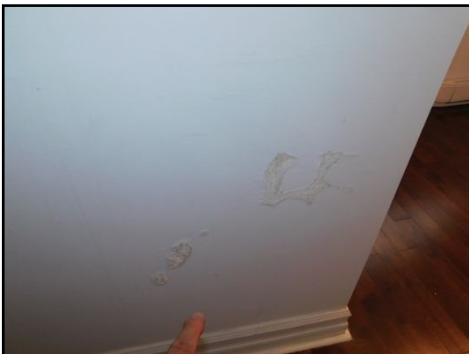
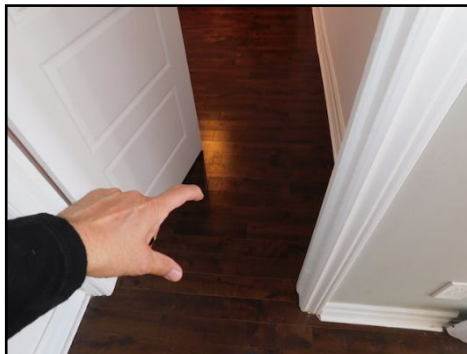
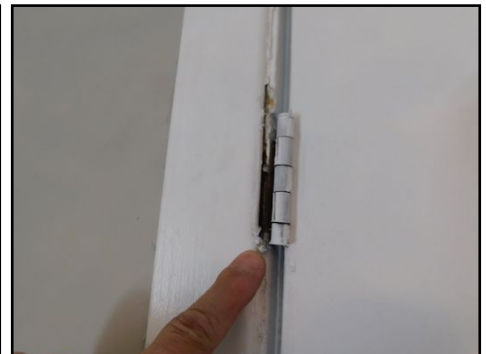
Walls and ceilings: Previous signs of water damage/infiltration observed. Dry at the time of the inspection.

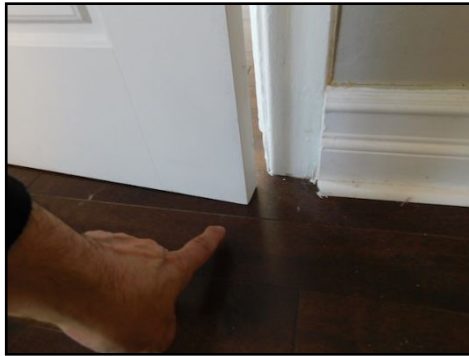
Door rubs on the floor

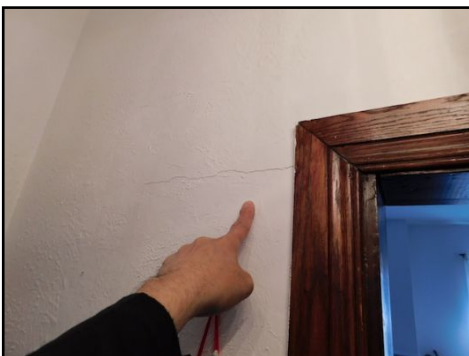
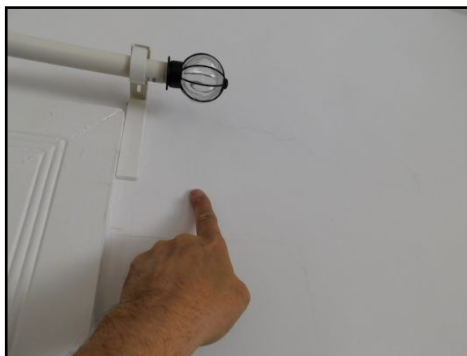
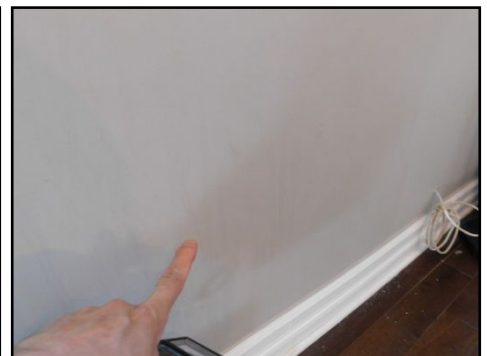
Water stains on the dining room drywall

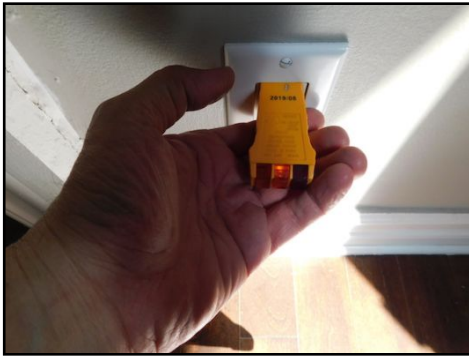
Electrical: - Outlets are not grounded (Also see main electrical).

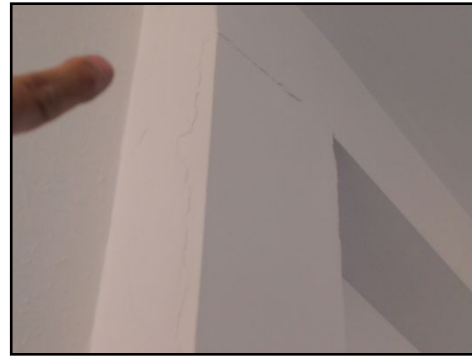
Walls and ceilings: Drywall/plaster, evidence of stress cracks in areas.

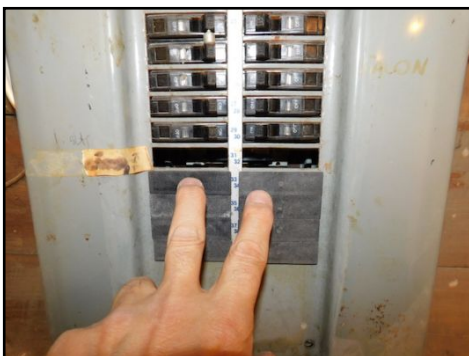
Missing cover and openings noted on the panels. Safety hazard. It is recommended to install a plastic cover or a dummy breaker to enhance safety.

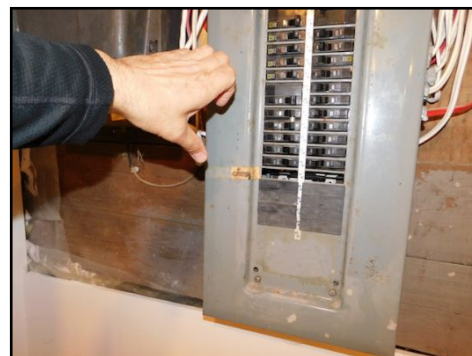
This is the older type electrical panel and it may no longer be acceptable by some insurance companies. It is recommended to consult with your insurance company for all rules and regulations that they may have regarding this situation.

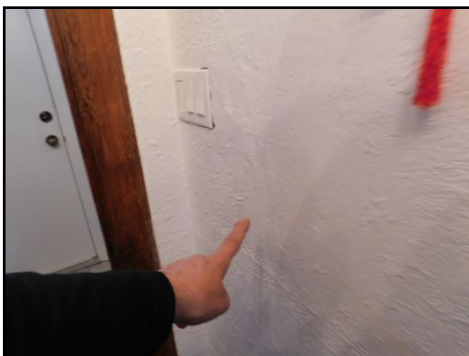
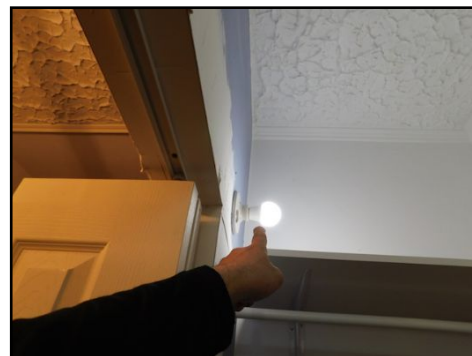
(Plaster/asbestos) General note on houses built up to 1989: Older buildings with plaster walls, drywall, joint compound, stucco, vinyl adhesive, and other building materials may contain asbestos. Please note that sampling and laboratory analysis are beyond the scope of this inspection. If the client wished further detailed information, a certified laboratory should be consulted.

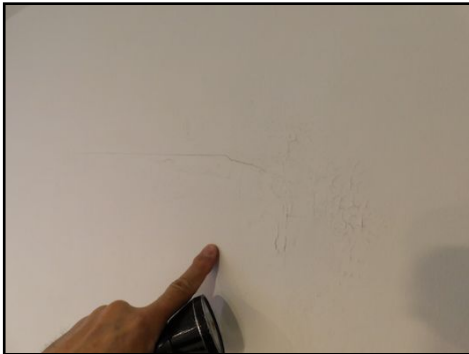
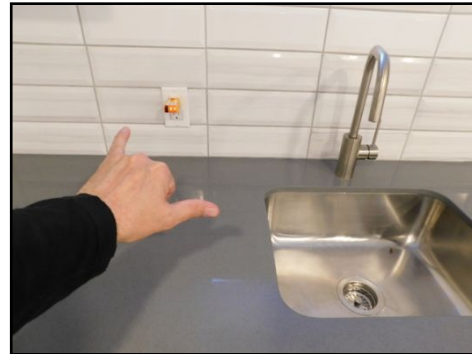
Walls and ceilings: Drywall, (next to the refrigerator) appears a little soft and paint is cracking and peeling. Recommend further verification behind this wall.

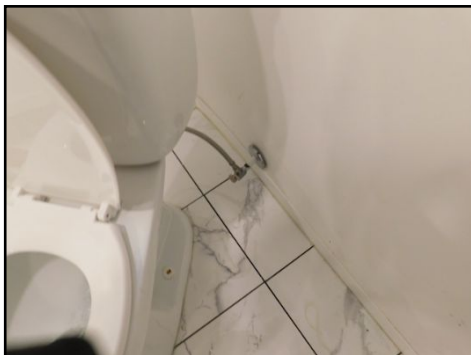
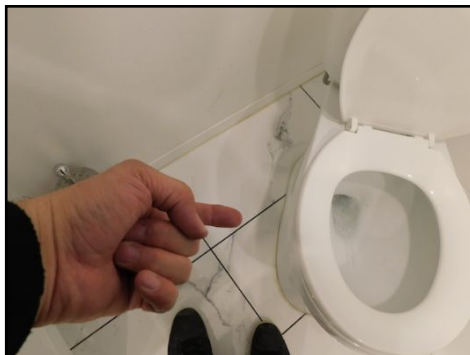
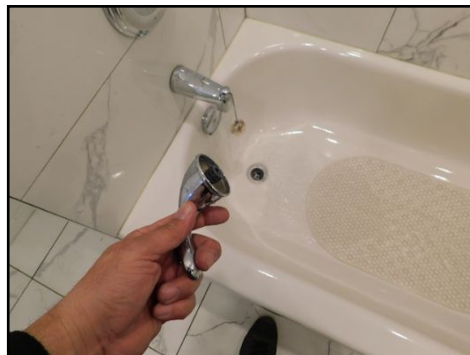
Toilet: Loose toilet was observed. (Mini bolts to hold it down missing).This condition could result leakage and damages to the subfloor and other components. Corrections are required.

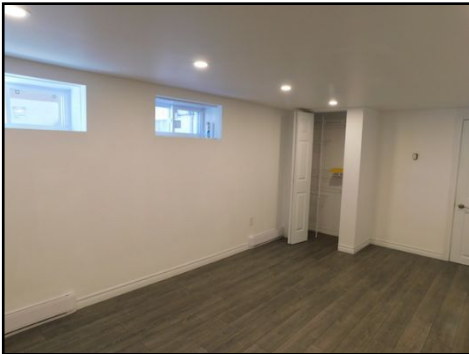
Windows: these windows are poor egress (Egress = emergency escape) for emergency escape. This is a safety hazard. This may not be allowed by some insurance companies.

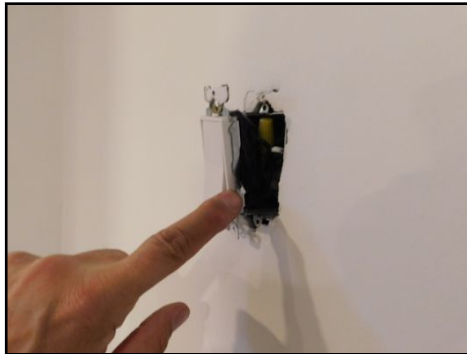
Safety hazard. To be repaired

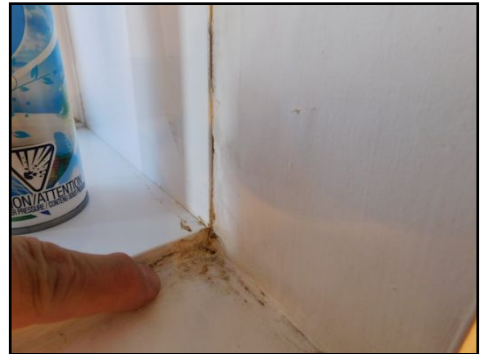
Walls and ceilings: Drywall. Previous signs of water damage/infiltration observed on the window sill sill. No moisture detected at the time of inspection. Verified with a moisture meter.

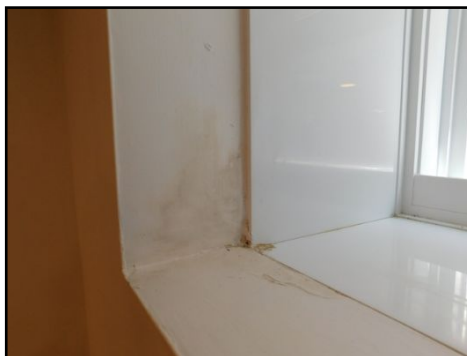
Walls and ceilings: Drywall. Previous signs of water damage/infiltration observed on the window sill sill. No moisture detected at the time of inspection. Verified with a moisture meter.

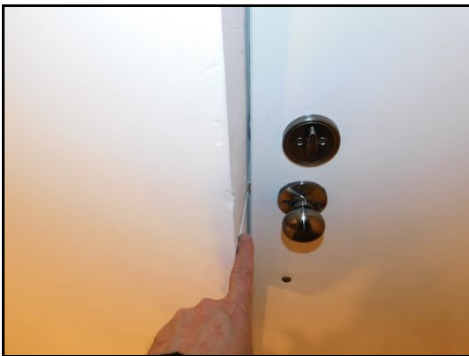
Front door rubs on the wall

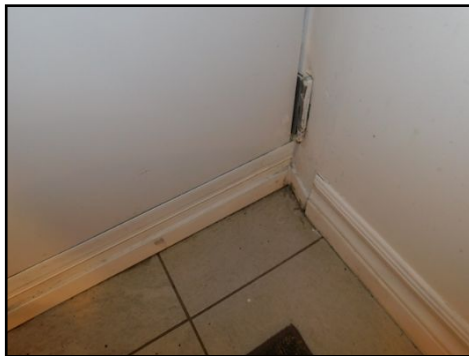
Appears to be previous water stains/infiltration/ Dry at the time.
Monitor the area and repair as needed.

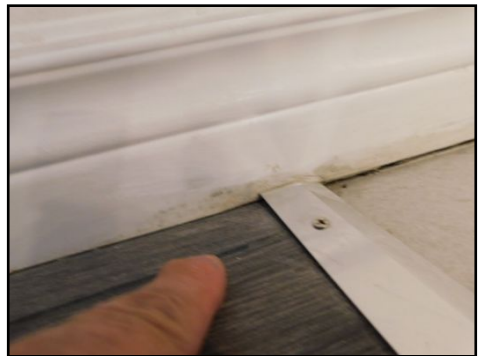
Walls and ceilings: There appears to be Mold like substance observed on the baseboards where it was not properly painted. Cannot confirm this is Mold, however, there were a few areas like this that was observed where it was not properly painted. If this is a concern, recommend further verification behind the baseboards.

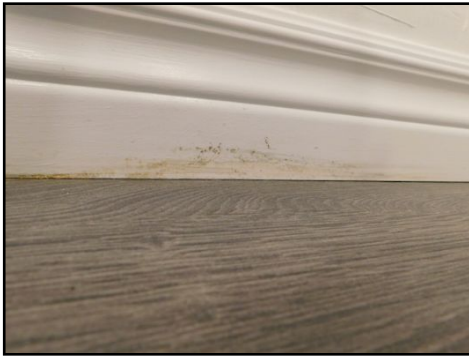
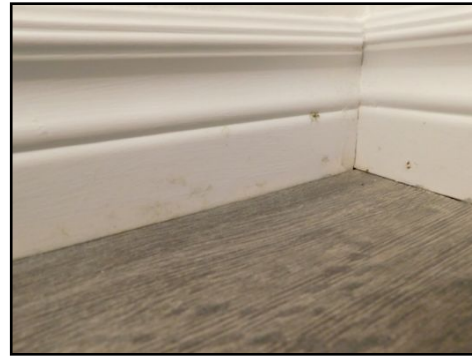
Walls and ceilings: There appears to be Mold like substance observed on the baseboards where it was not properly painted. Cannot confirm this is Mold, however, there were a few areas like this that was observed where it was not properly painted. If this is a concern, recommend further verification behind the baseboards.

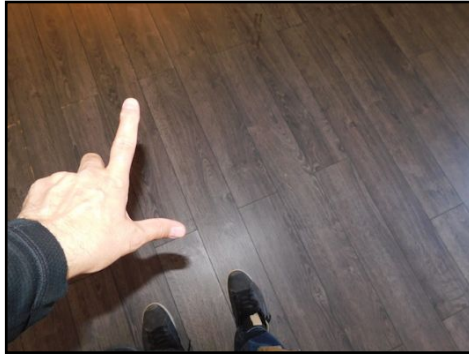
The floor drain pit has been covered by the flooring. No access. Access to the drain pit must be accessible. Drain pit also observed on the exterior.

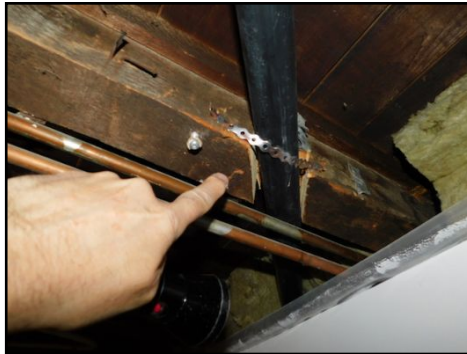
Joists have been improperly notched; repair advised. Notches on ends of joists should not exceed 1/4 the depth of the joist. Notches should not be located in the middle 1/3 of the joist.

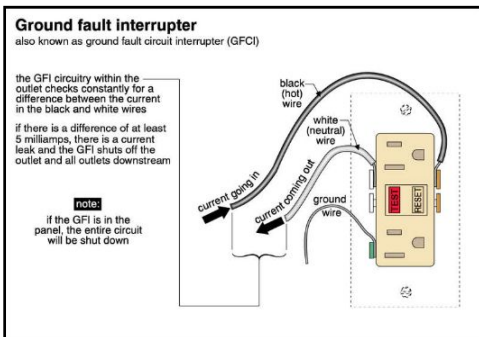
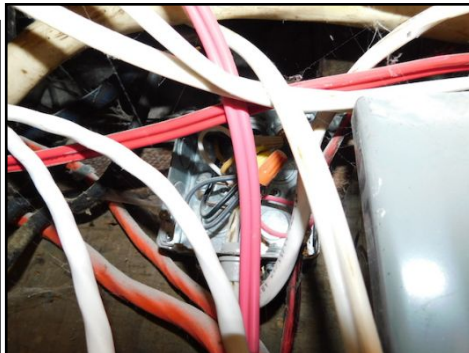
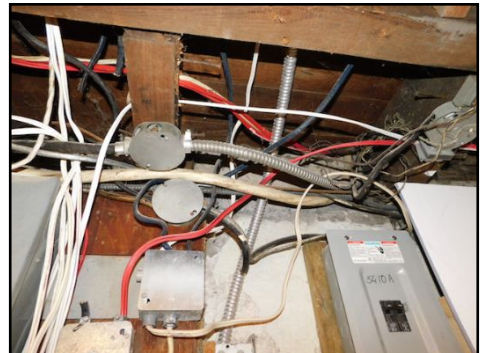
For kitchen/bathroom/exterior/garage Open junction boxes without cover were observed, this is a safety concern. Recommend installing proper covers to enhance safety.

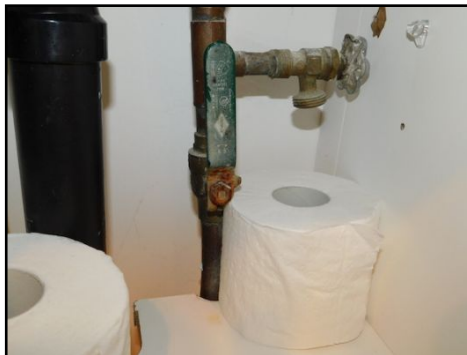
Located in the basement bathroom, under the sink

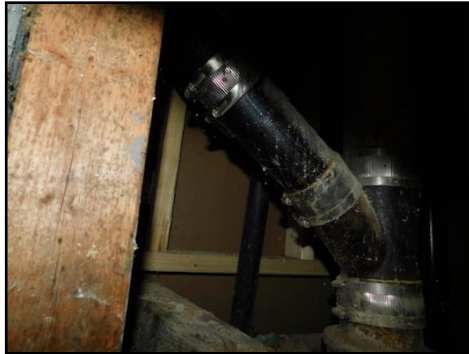
Although large portion of the plumbing drainage system has been upgraded to the ABS plastic, however they are connected to the original cast iron piping. Also, piping within the walls may also be still the original cast iron piping. (inspection limitation due to limited access).

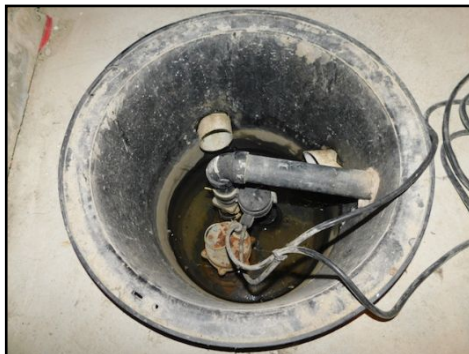
Sump pit cover is missing, suggest installing cover for safety.

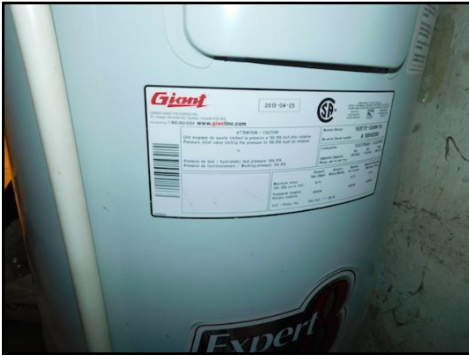
Year manufactured: 2013 (It is towards the end of its life expectancy and it will require to be replaced soon. This is recommended by the insurance companies).

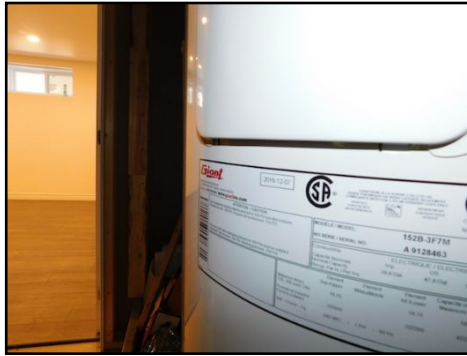
Year manufactured: 2018

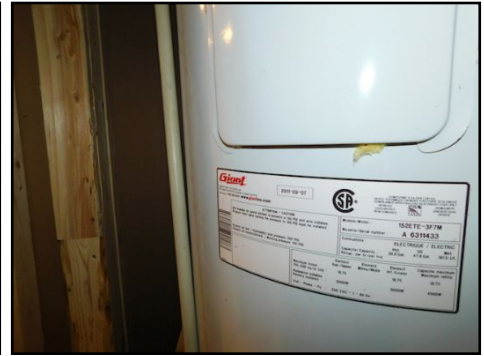
Year manufactured: 2011 (It has passed its life expectancy and it requires to be replaced. Recommended by insurance company).

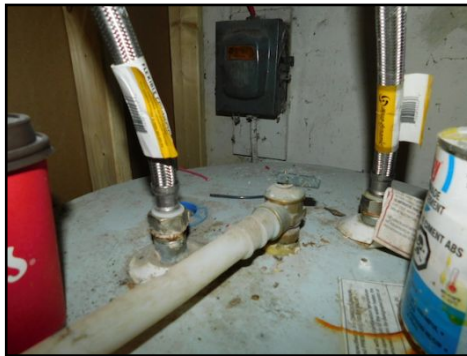
Corrosion noted at fittings. (One of them). No leaks observed.
